CONNECTICUT RIVER BASIN
GARDNER , MASSACHUSETTS

PERLEY BROOK RESERVOIR DAM
MA 00119

**PHASE I INSPECTION REPORT
NATIONAL DAM INSPECTION PROGRAM**

JUNE 1980

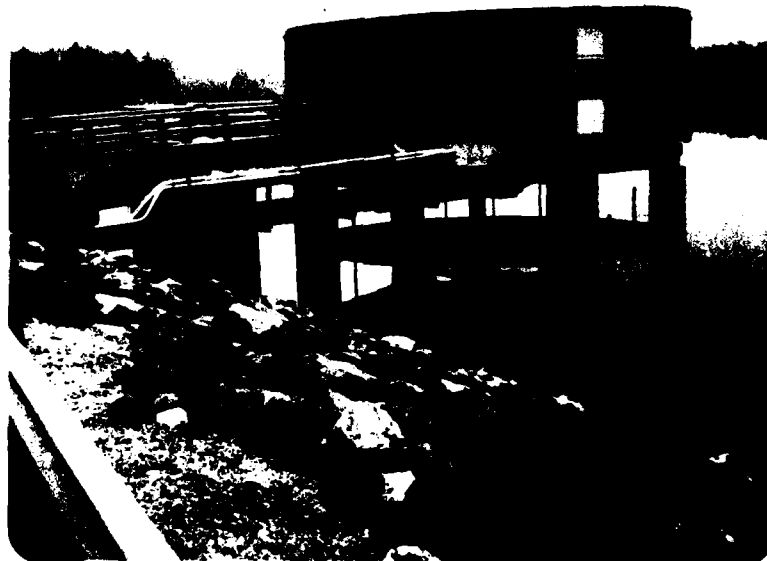
NO. 1 VIEW OF PUMP STATION AND SPILLWAY
